MSW PA\_73A\_CP\_20260519\_Investigation  
**Texas Commission on Environmental Quality**  
**Investigation Report**

**Regulated Entity Name: CITY OF AMARILLO LANDFILL**

**Investigation #** 2152537

**Investigation Type:** Compliance Investigation

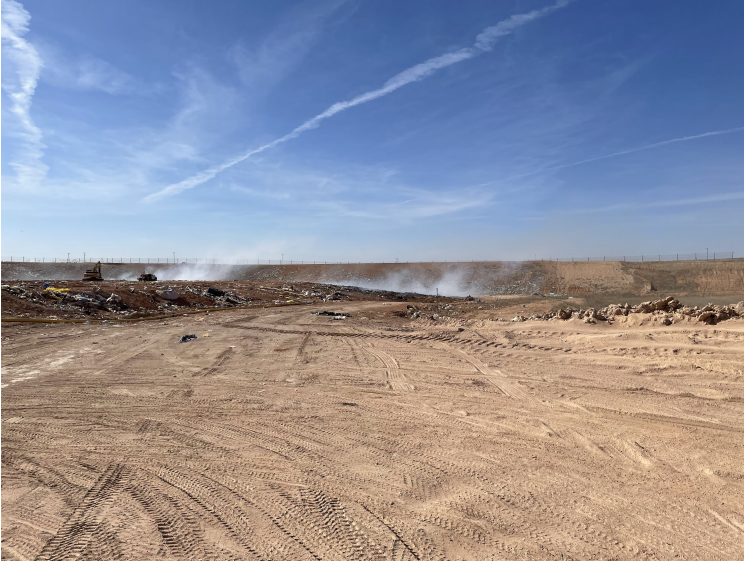
Photo #1

Comments: Looking southeast within the permitted boundary of the City of Amarillo Landfill. Photo focuses on the landfill's working face (Cell 10) with observed smoke from deposited waste. Photo taken May 19, 2026.

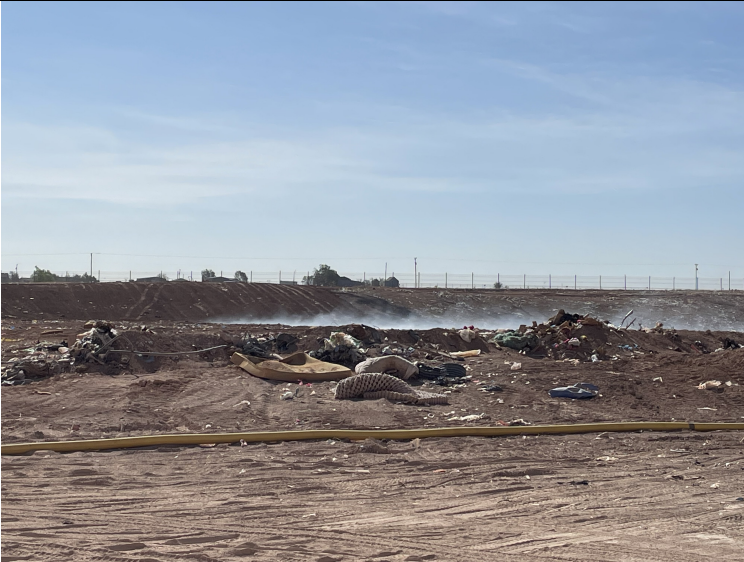
Photo #2

Comments: Looking southeast within the permitted boundary of the City of Amarillo Landfill. Photo focuses on the landfill's working face (Cell 10) with observed smoke from deposited waste. Photo taken May 19, 2026.

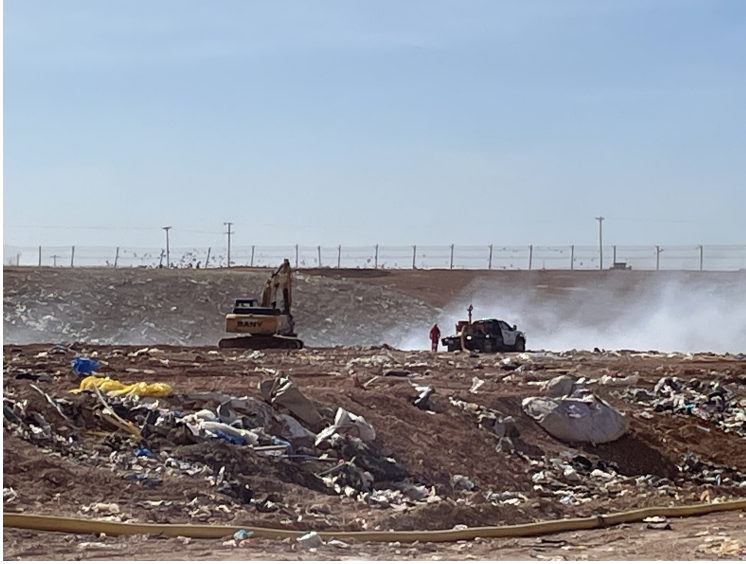
Photo #3

Comments: Looking southeast within the permitted boundary of the City of Amarillo Landfill. Photo focuses on the landfill's working face (Cell 10) with observed smoke from deposited waste. A trackhoe and truck are also observed on the deposited waste with a worker working on fire suppression. Photo taken May 19, 2026.

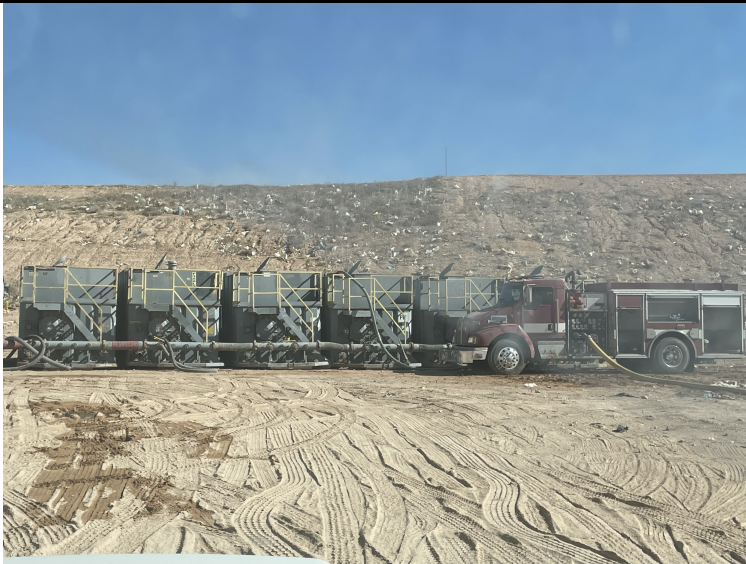
Photo #4

Comments: Looking north within the permitted boundary of the City of Amarillo Landfill. Photo focuses on water tanks on-site being used for fire suppression. Photo taken May 19, 2026.

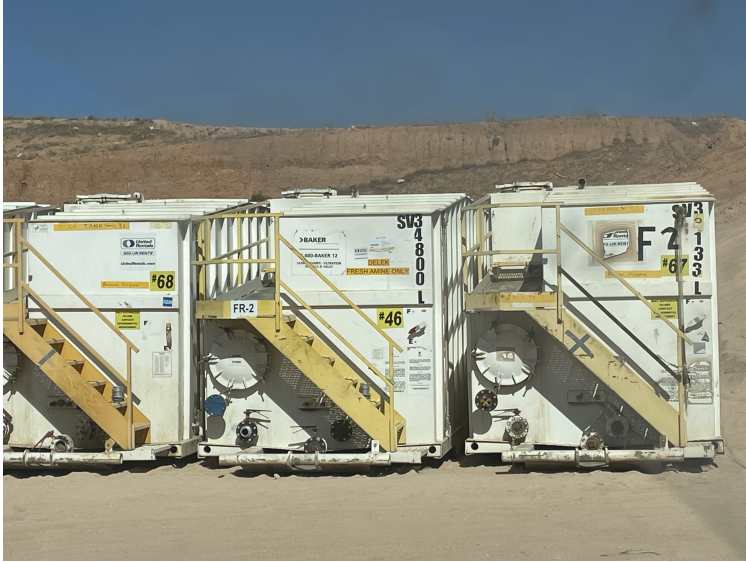
Photo #5

Comments: Looking west within the permitted boundary of the City of Amarillo Landfill. Photo focuses on specialized chemical tanks on-site being used for fire suppression. Photo taken May 19, 2026.

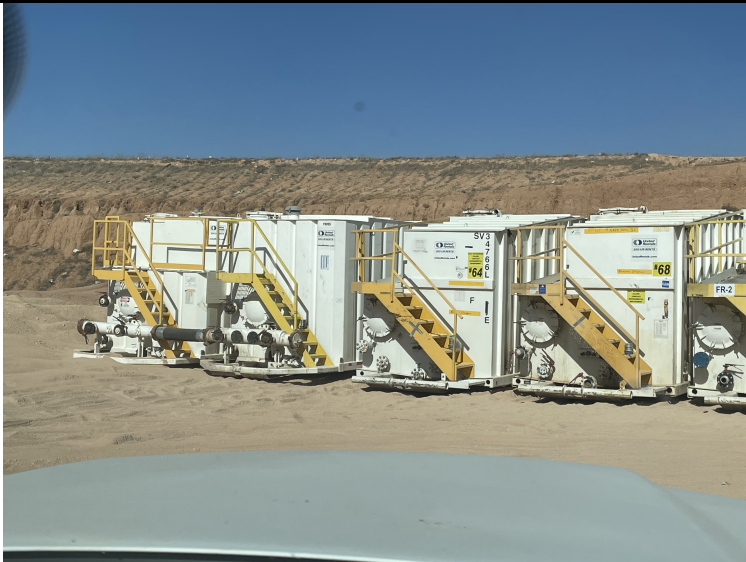
Photo #6

Comments: Looking west within the permitted boundary of the City of Amarillo Landfill. Photo focuses on specialized chemical tanks on-site being used for fire suppression. Photo taken May 19, 2026.

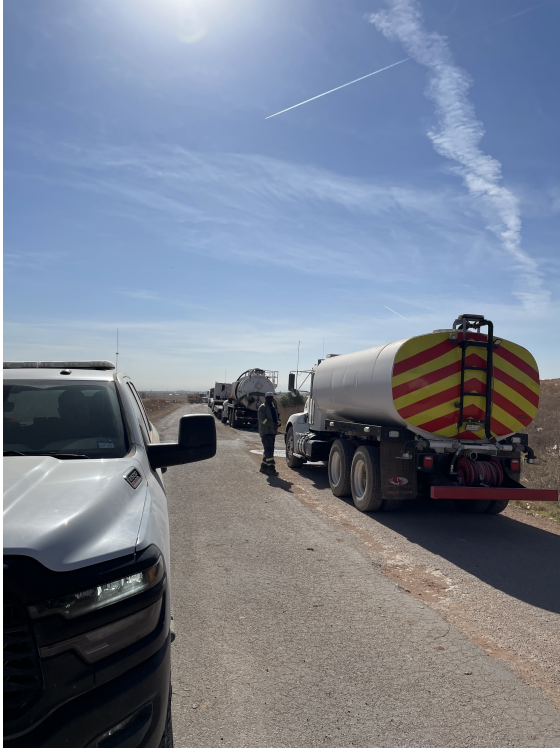
Photo #7

Comments: Looking east within the permitted boundary of the City of Amarillo Landfill. Photo focuses on water tank trucks online for fire suppression. Photo taken May 19, 2026.

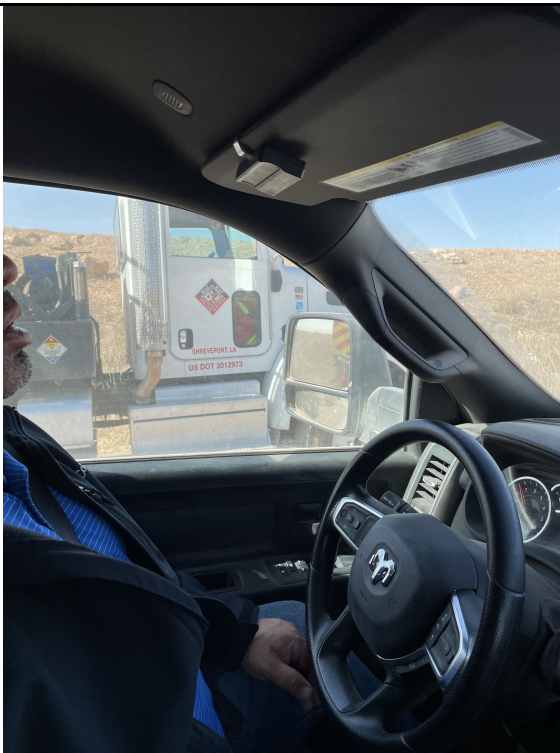
Photo #8

Comments: Looking south within the permitted boundary of the City of Amarillo Landfill. Photo focuses on a water tank truck online for fire suppression and noted the company's logo on the door. Photo taken May 19, 2026.
